Subject: Global AMOC for AD 2012-10-53

EMERGENCY AIRWORTHINESS DIRECTIVE

AD #: 2012-10-53

2012-10-53 **EUROCOPTER DEUTSCHLAND GMBH (ECD):** Directorate Identifier 2012-SW-049-AD.

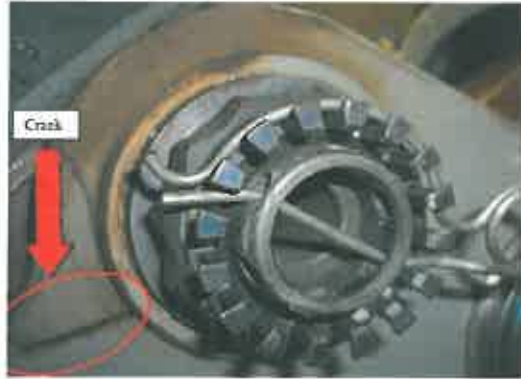
Figure 1

This EAD defines the unsafe condition as a crack in the MRH shaft flange, which could result in failure of the MRH shaft and subsequent loss of control of the helicopter.

(1) Before further flight, and thereafter at intervals not to exceed 6 hours TIS, check the MRH shaft lower flange and the visible area of the MRH shaft upper flange for a crack. Figures 1 and 2 of this EAD are examples of cracks that have been discovered in the MRH shaft lower flange. The actions required by this paragraph may be performed by the owner/operator (pilot) holding at least a private pilot certificate, and must be entered into the aircraft records showing compliance with this EAD in accordance with 14 CFR §§ 43.9 (a)(1)-(4) and 14 CFR § 91.417(a)(2)(v). The record must be maintained as required by 14 CFR §§ 91.417, 121.380, or 135.439.

(3) If there is a crack in the upper or lower MRH shaft flange, before further flight, replace the MRH shaft.

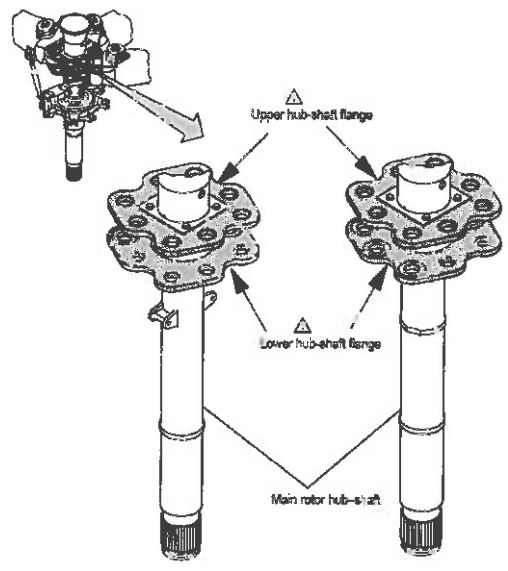
Figure 3

(ii) Clean the upper and lower MRH shaft flange as depicted in figure 3 of this EAD and visually inspect for a crack.

△ Check visible area of the upper and lower hub-shaft flange.

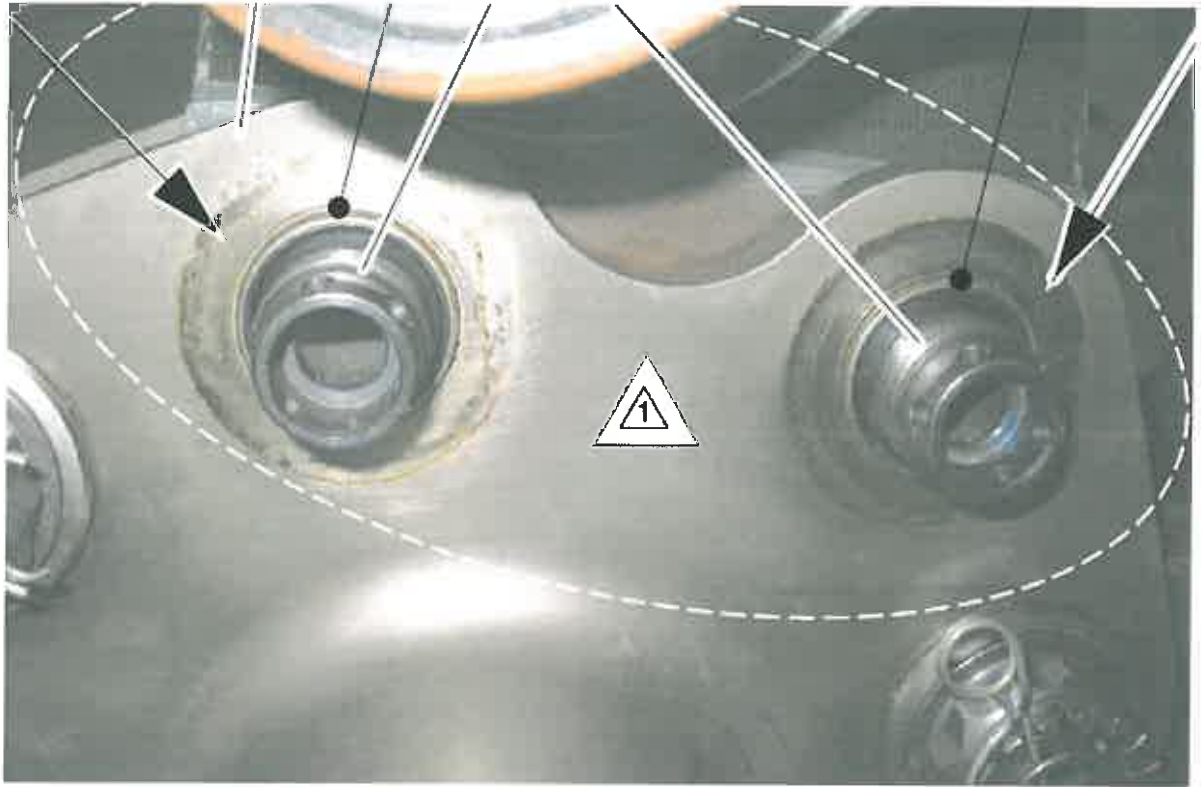
Figure 4

(v) Using a 10X or higher power magnification, inspect all lower MRH shaft flange blade bolt attachment areas for a crack as shown in figure 4 of this EAD.
