Subject: Global AMOC for AD 2012-10-53

EMERGENCY AIRWORTHINESS DIRECTIVE

AD #: 2012-10-53

2012-10-53 EUROCOPTER DEUTSCHLAND GMBH (ECD): Directorate Identifier 2012-SW-049-AD.

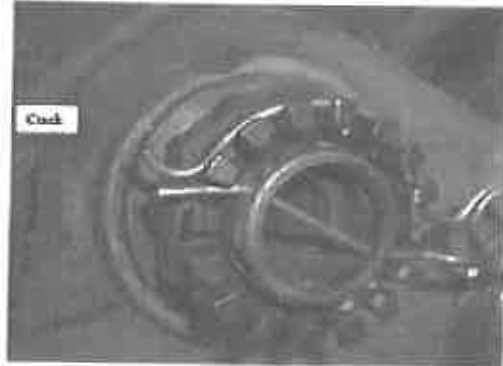
Figure 1

This EAD defines the unsafe condition as a crack in the MRH shaft flange, which could result in failure of the MRH shaft and subsequent loss of control of the helicopter.

(1) Before further flight, and thereafter at intervals not to exceed 6 hours TIS, check the MRH shaft lower flange and the visible area of the MRH shaft upper flange for a crack. Figures 1 and 2 of this EAD are examples of cracks that have been discovered in the MRH shaft lower flange. The actions required by this paragraph may be performed by the owner/operator (pilot) holding at least a private pilot certificate, and must be entered into the aircraft records showing compliance with this EAD in accordance with 14 CFR §§ 43.9 (a)(1)-(4) and 14 CFR § 91.417(a)(2)(v). The record must be maintained as required by 14 CFR §§ 91.417, 121.380, or 135.439.

(3) If there is a crack in the upper or lower MRH shaft flange, before further flight, replace the MRH shaft.

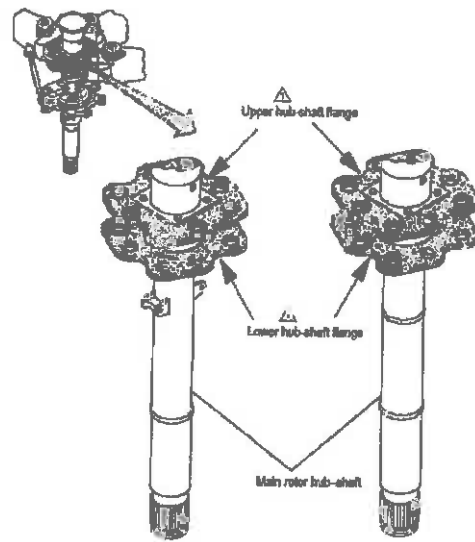
Figure 3

(ii) Clean the upper and lower MRH shaft flange as depicted in figure 3 of this EAD and visually inspect for a crack.

⚠ Check visible area of the upper and lower hub-shaft flange.

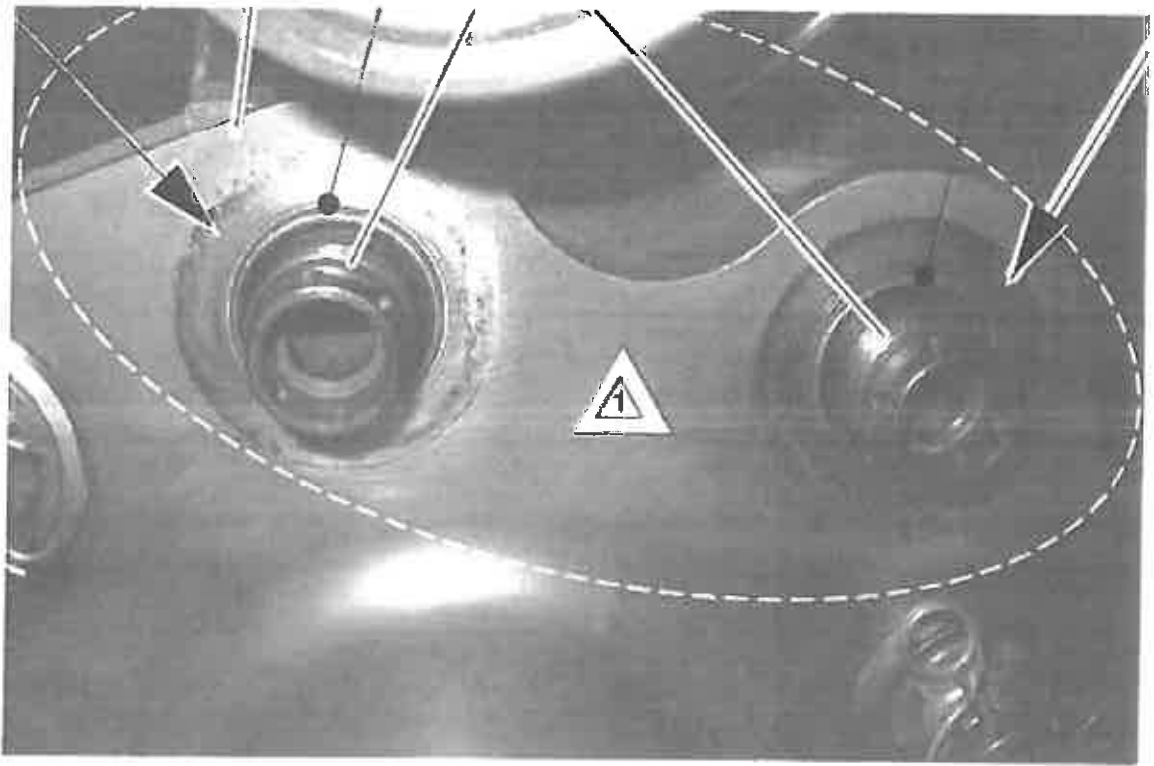
Figure 4

(v) Using a 10X or higher power magnification, inspect all lower MRH shaft flange blade bolt attachment areas for a crack as shown in figure 4 of this EAD.
