Subject: Global AMOC for AD 2013-16-14

Airworthiness Directives; Eurocopter Deutschland GmbH Helicopters

ALERT SERVICE BULLETIN

Retrofit of a corrugated washer in the filter housing

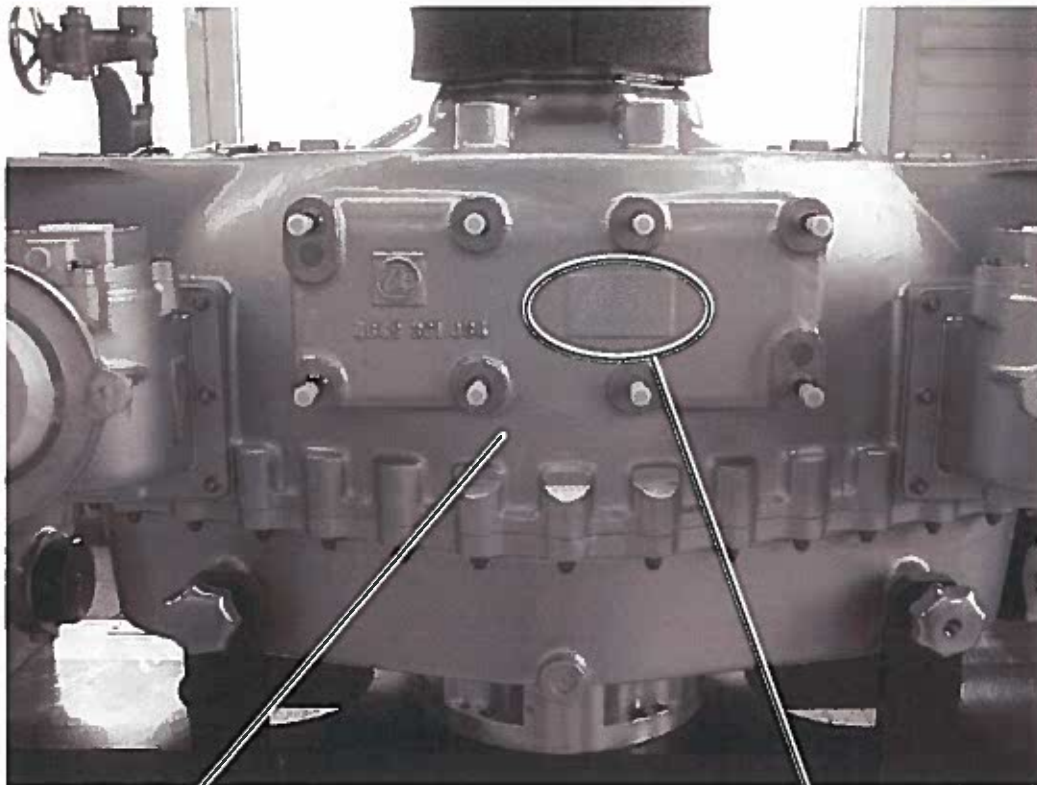
S/N Position of the Housing Upper Part
Figure 1

NOTE The S/N of the housing upper part is given in the log card of the main transmission and on the housing upper part (see Figure 1).

Main transmission shown when removed.
It is not required to remove the main transmission and the main transmission drive in order to identify the S/N of the housing upper part.

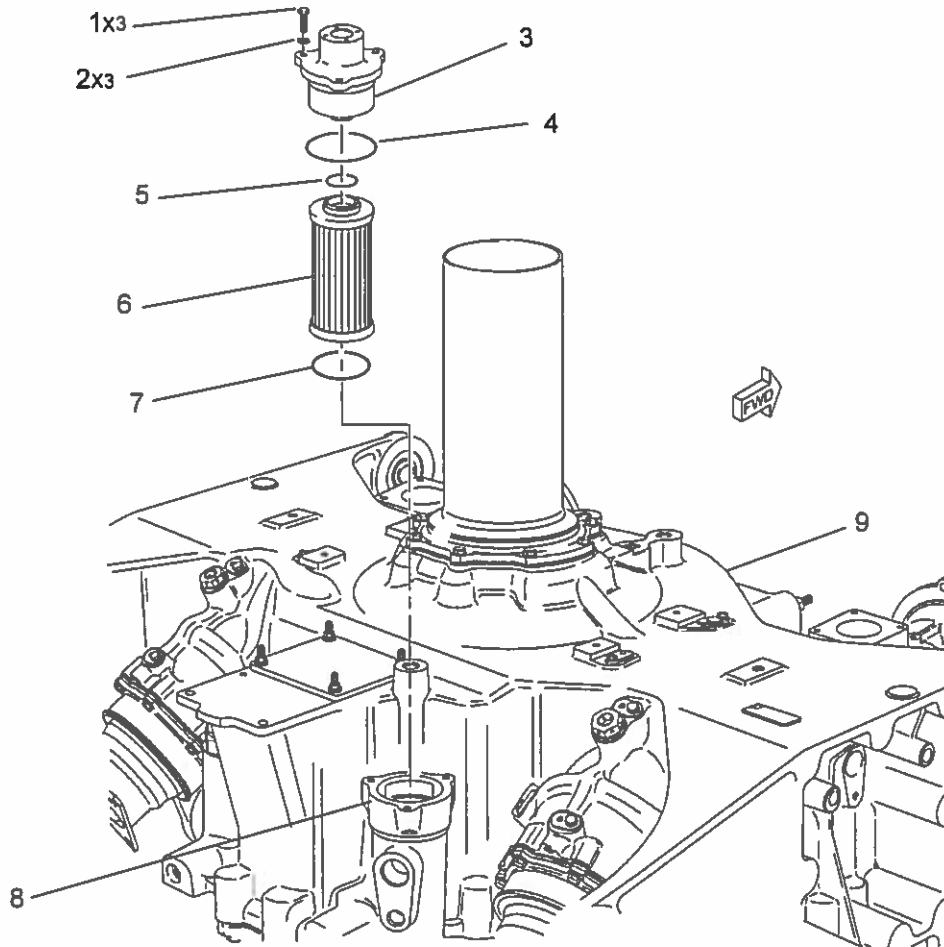
Housing Upper Part - Installation of corrugated washer
Figure 2

On some of the housing upper parts for the main transmission FS108 which are manufactured by ZFL an inspection has shown that the bypass inlet in the oil filter area has not been worked i.a.w. the design document. With this Alert Service Bulletin an equivalent structural design is established for the oil supply to the bypass by installing a corrugated washer.

- 1 Remove LH and RH transmission fairings i.a.w. AMM, 71-11-00, 4-4.
- 2 Remove oil filter element i.a.w. AMM, 63-21-00, 4-5.
- 3 Install the corrugated washer (7, Figure 2) in the middle of the filter housing (8) of the housing upper part of the main transmission (see also Figure 3).
- 4 Install oil filter element i.a.w. AMM, 63-21-00, 4-5.
- 5 Install LH and RH transmission fairings i.a.w. AMM, 71-11-00, 4-4.
- 6 Enter the following in the log card of the main transmission: "ASB EC135-63A-017 accomplished. Housing upper part of the main transmission must be reworked at the next major repair or major overhaul measure for the main transmission, but no later than 5000 Fh (+ 150 Fh tolerance) after receipt of Revision 0 of this Alert Service Bulletin".

Install corrugated washer in the middle of the filter housing.
