Subject: **GLOBAL AMOC for AD 2014-22-51**
Attachments: AD 2014-22-51 Dated January 16 2015
GLOBAL AMOC Dated Nov 12th, 2015
EASB 05A020 Rev 1 dated Oct 22 2015
SB 79-001 mod 074547 dated October 22 2015

AIRWORTHINESS DIRECTIVE

2014-22-51 Airbus Helicopters (Formerly Eurocopter France): Amendment 39-18088; Docket No. FAA-2015-0133; Directorate Identifier 2014-SW-066-AD.

EMERGENCY ALERT SERVICE BULLETIN

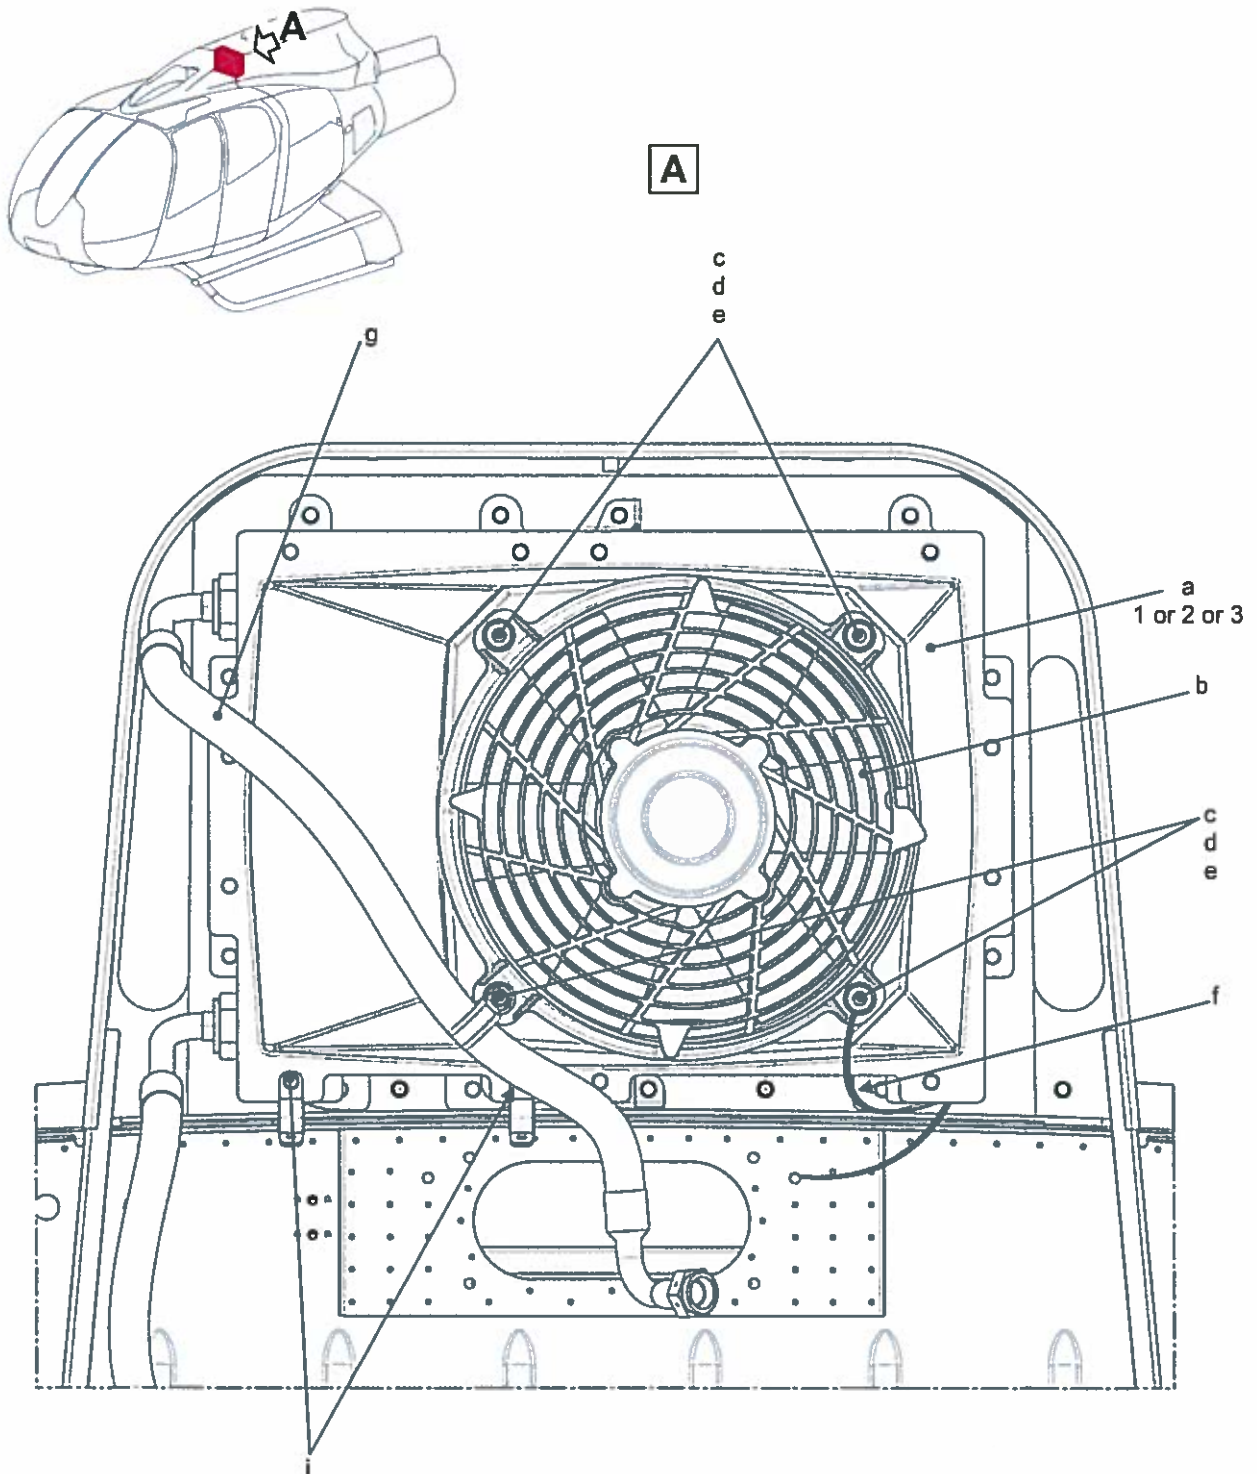
Figure 1

- Check for cracks the hopper (a) (Figure 1) especially at the attachments of the fan (b):

- Replace the hopper (a):
 - . Replace the hopper (a) (Figure 1) with hopper (1), (2) or (3) as per AMM Task 79-21-00, 4-3,
 - . Comply with Service Bulletin No. 79-001 (embodiment of modification 074547).

- . Remove and retain the screws (c) (Figure 1), washers (d) and spacers (e).
 - . Remove the bonding braid (f) from the fan.
 - . Remove and retain the fan (b).

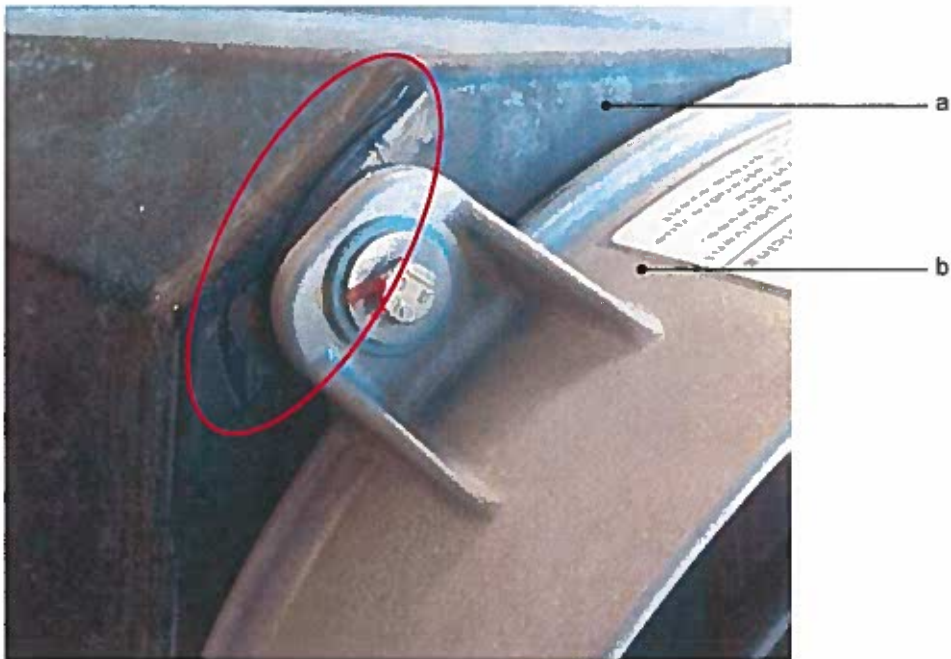
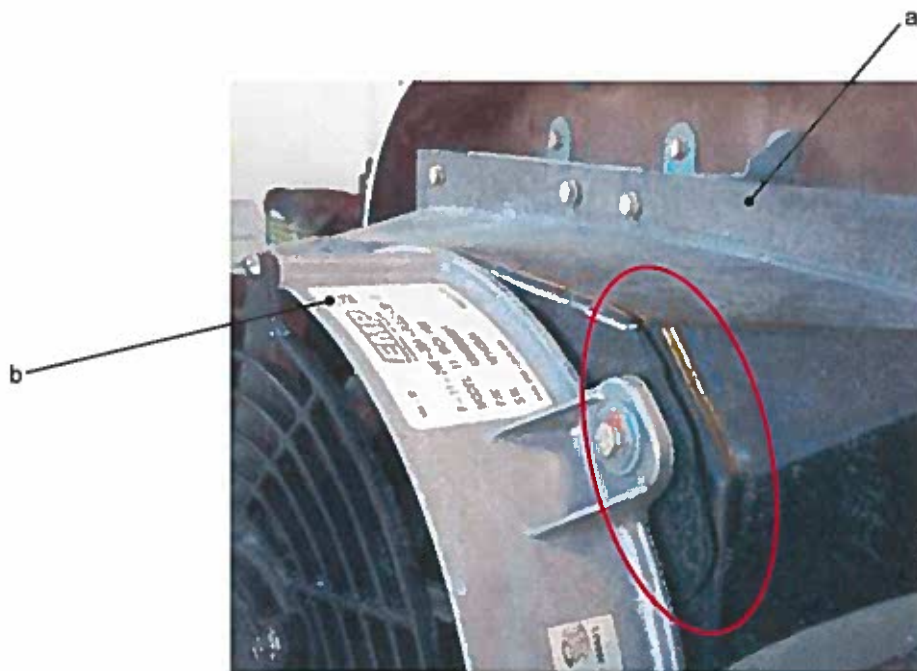
Figure 2

Airbus Helicopters has been informed of several cases of cracks at the attachment points of the fan to the hopper. (See examples of cracks, [Figure 2](#)).

Cracks can lead to the total failure of the fan attachment.

The fan can then interfere with the control rod of the front servocontrol or the flight control bellcrank and thus cause jamming.

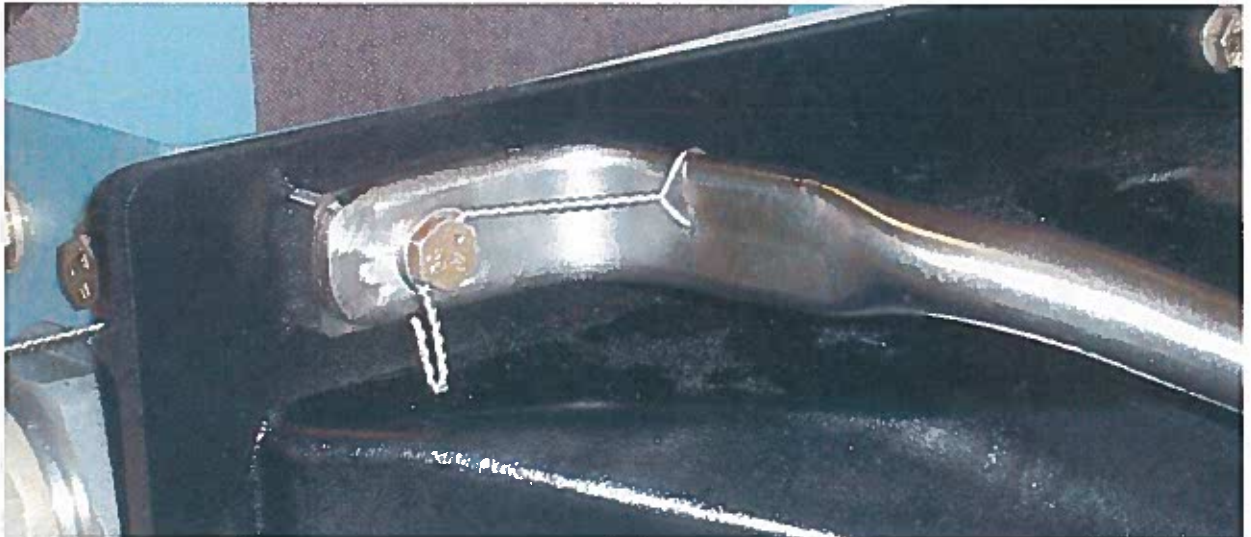
Safetying principle of the bolt on the rod (See photo below)

To safely the attachment bolt of the rod, use the drilling of the bolt head on the one hand and the drilling on the rod on the other hand.
