**Subject: GLOBAL AMOC for AD 97-26-03**

Docket No. 97-SW-45-AD; Amendment 39-10246; AD 97-26-03

Airworthiness Directives; EUROCOPTER DEUTSCHLAND Model MBB-BK 117 A-1, A-3, A-4, B-1, B-2, and C-1 helicopters

**No. ASB MBB-BK117-10-114**

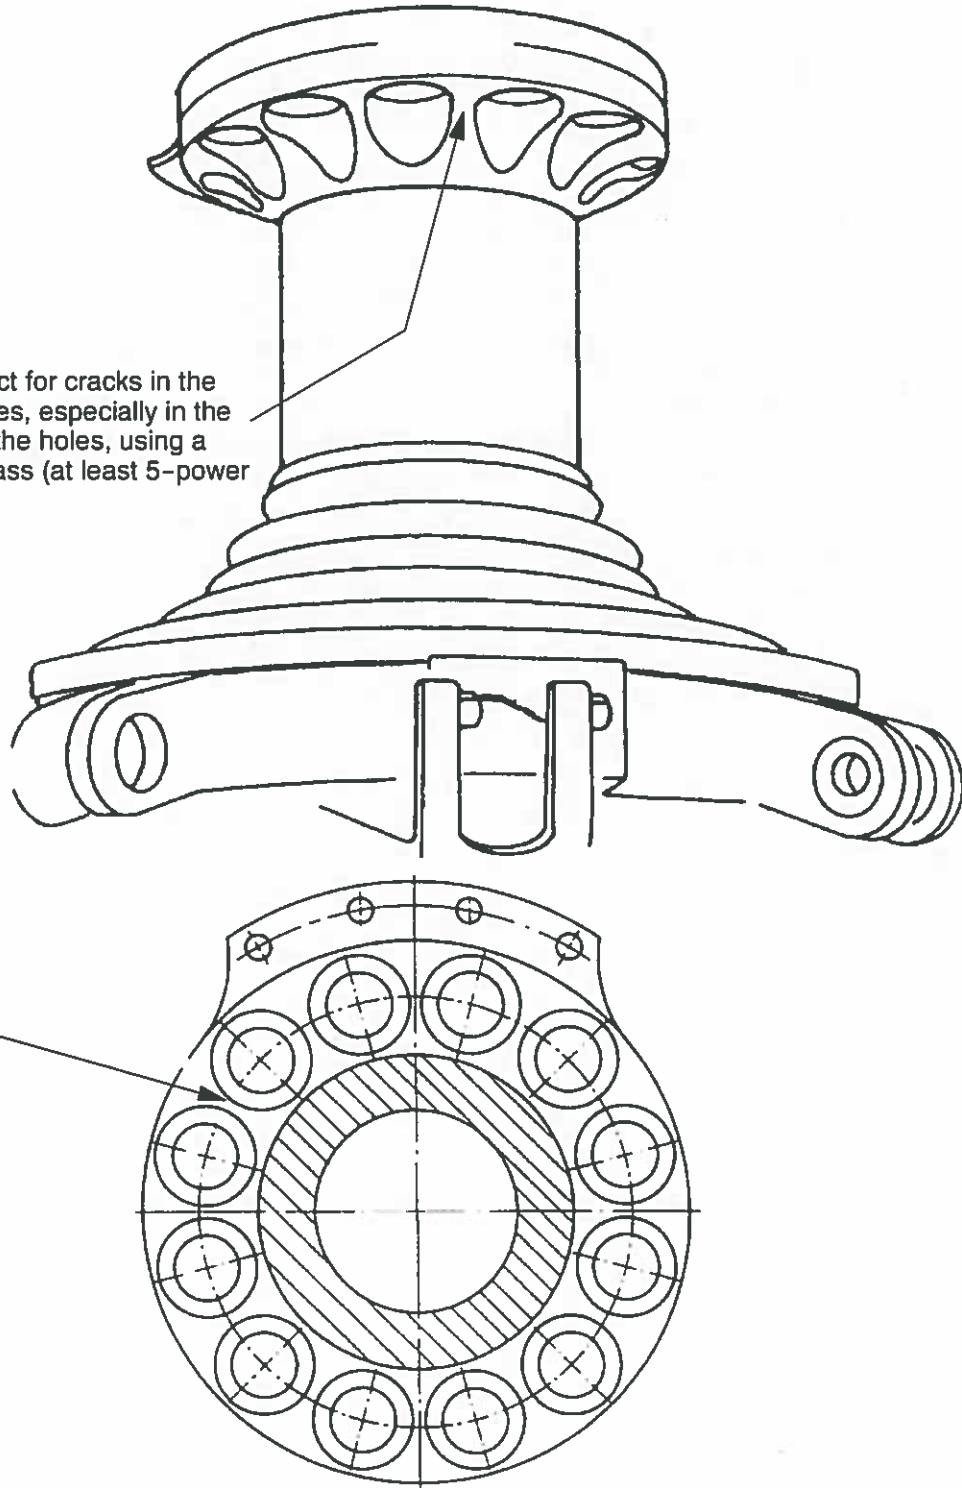
Figure 1

A rotor mast was found to have cracks of critical magnitude in the area of the flange. The rotor mast flange must be subjected to an immediate visual crack inspection which is to be repeated at intervals until further notice.

2.A.2. Using a magnifying glass (at least 5-power magnification), visually inspect for cracks in the area of the holes on the underside of the rotor mast flange, especially in the ribs between the holes (see figure 1). If required, remove lockwire and, if necessary, the nuts to determine whether suspected cracks are evident. If the nuts are to be removed, remove only one nut and reinstall the nut prior to removing the next nut per MM, Chapter 13. Before tightening each nut, make certain that its mating stud was not loosened when the nut was previously removed. If a stud is found to be loose, screw it in until the stud abuts, before installing the nut.

Rotor mast flange

Visually inspect for cracks in the area of all holes, especially in the ribs between the holes, using a magnifying glass (at least 5-power magnification)

2.A.3. If any cracks are found, contact the AHD Customer Support prior to the next flight for advice on how to proceed.
