Subject: **GLOBAL AMOC for AD 2014-22-51**
Attachments: AD 2014-22-51 Dated January 16 2015
GLOBAL AMOC Dated Nov 12th, 2015
EASB 05A020 Rev 1 dated Oct 22 2015
SB 79-001 mod 074547 dated October 22 2015

AIRWORTHINESS DIRECTIVE

2014-22-51 Airbus Helicopters (Formerly Eurocopter France): Amendment 39-18088; Docket No. FAA-2015-0133; Directorate Identifier 2014-SW-066-AD.

EMERGENCY ALERT SERVICE BULLETIN

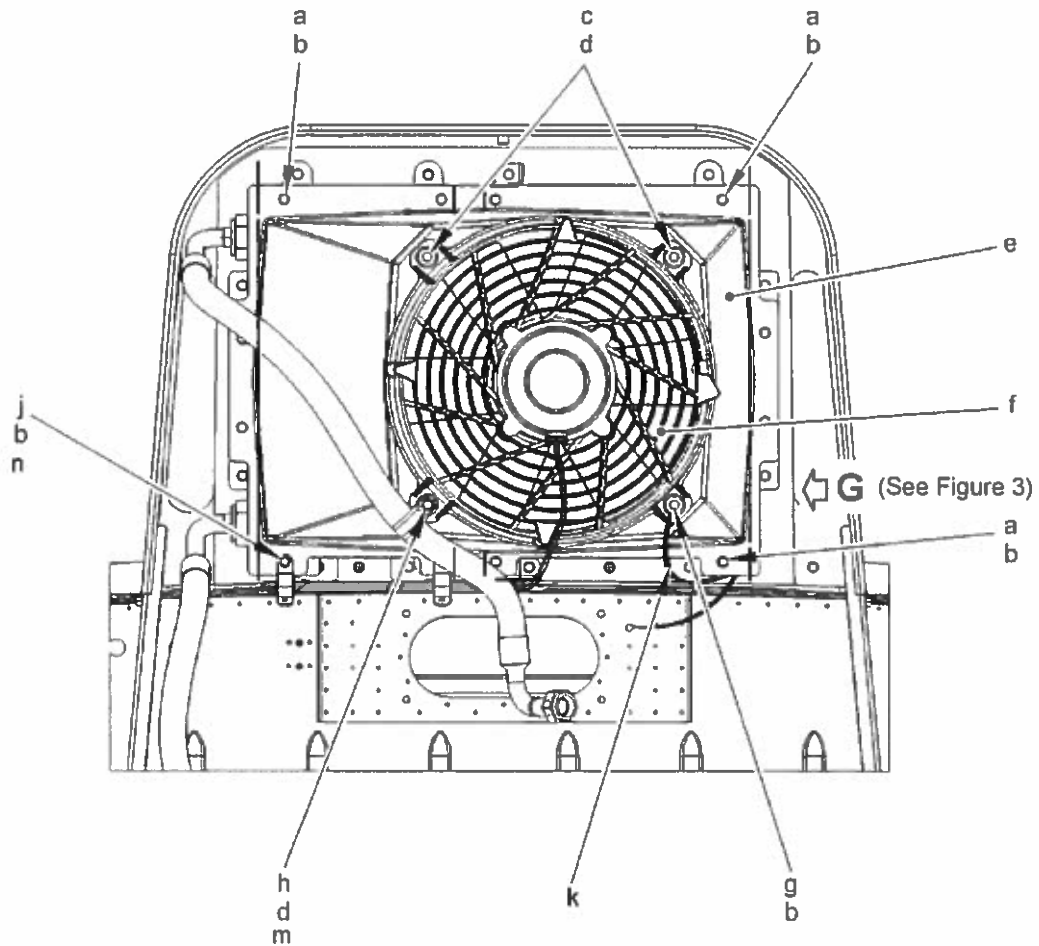
Figure 1

- Check for cracks on hopper (e) (Figure 1) especially on fan (f) attachments.

- .. replace hopper (e) as per AMM Task 79-21-00, 4-3,
- .. and comply with paragraph 3.B.3.
